**Technical report**  
**of**  
**inspection on gearbox PPSC1290-A115**

This document presents the results of the inspection on gearbox type PPSC1290-A115.

Gearbox Type PPSC1290-A115

**Technical report  
of  
vibration measurement on gearbox PPSC1290-A115**

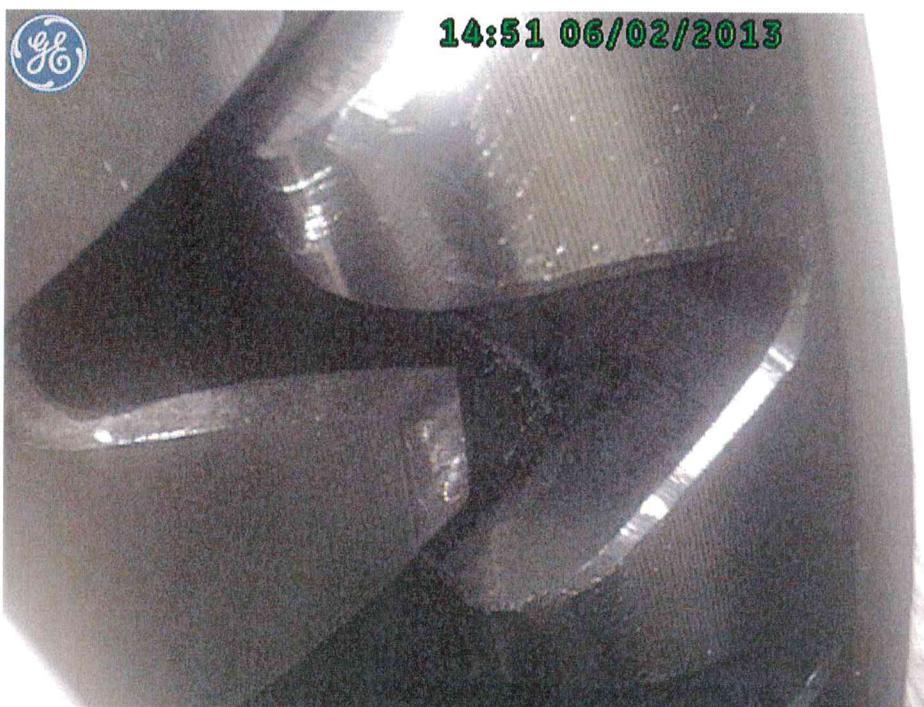
Picture 1: Intermediate gear mesh, planet- ring gear

A service engineer of Exxon Mobil inspected the gearbox on February 6. 2013. The pictures indicate a loose mesh between planet and ring gear of the intermediate planetary stage, see Picture 1. Dark lines in radial direction on the tooth flank are presented in Picture 2. These lines are visible on the ring gear of the main planetary stage and the intermediate planetary stage.

The gear mesh of planet and ring gear of the intermediate planetary stage is slight loose, but the function of the mesh is not restricted.

The visual inspection as well as the vibration measurement indicates a good condition of the gearbox. For the whole gearbox no special action is recommended.

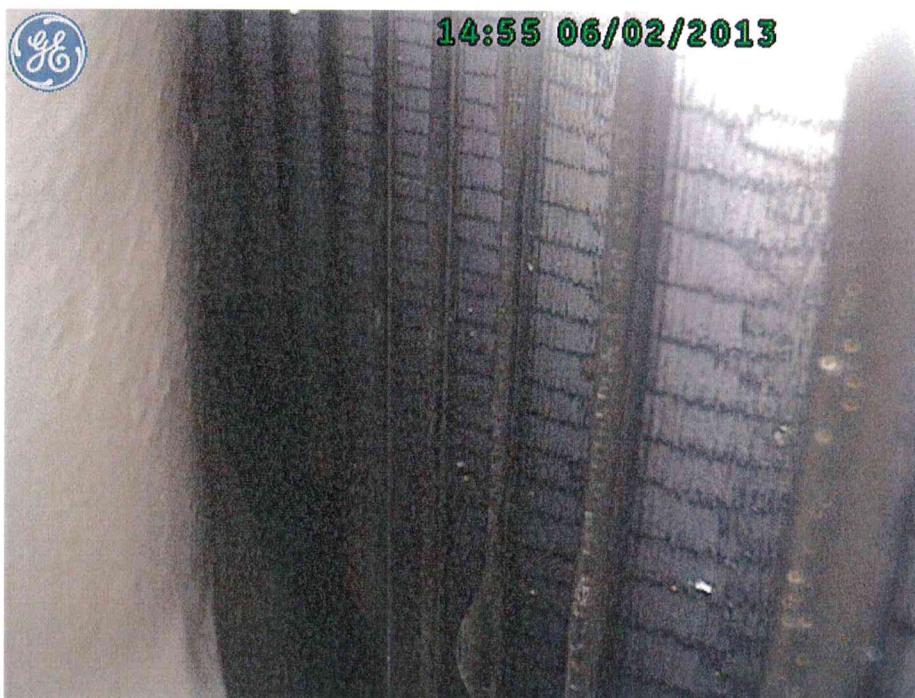
Picture 2: Intermediate gear mesh, ring gear

Dark lines in radial direction on the tooth flank are a typical result of the machining process of the ring gear. The machining process of the ring gear only includes milling. No surface hardening or grinding is applied.

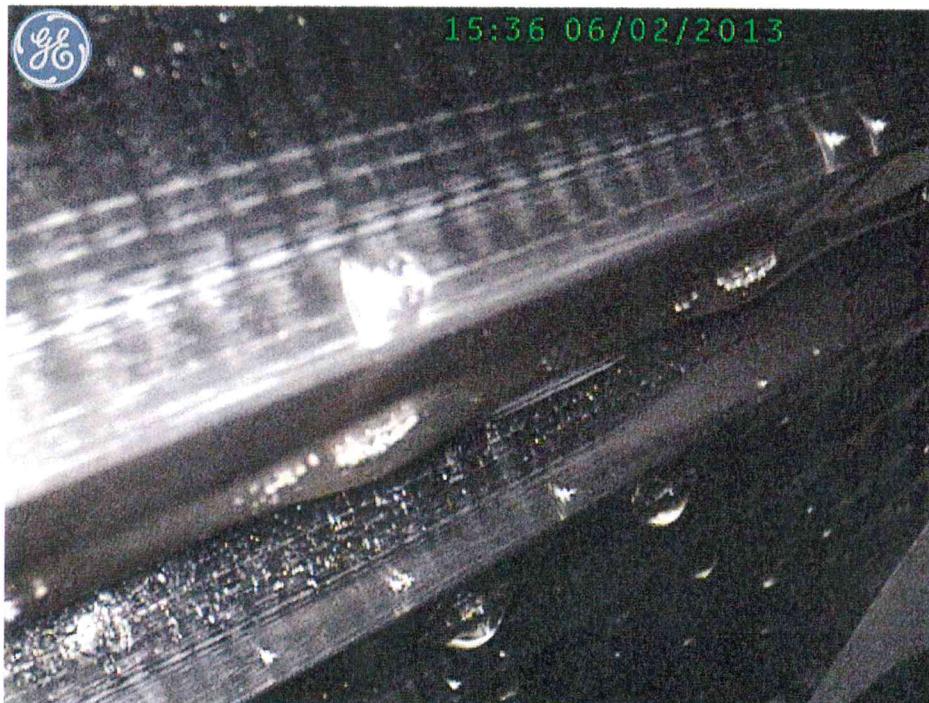
Picture 3: Main gear mesh, ring gear

On the ring gear of the main stage a grey area on the flank is visible, see Picture 3.

The grey area on the flank of the ring gear of the main planetary stage seems to be a reflection caused by the lubricant.

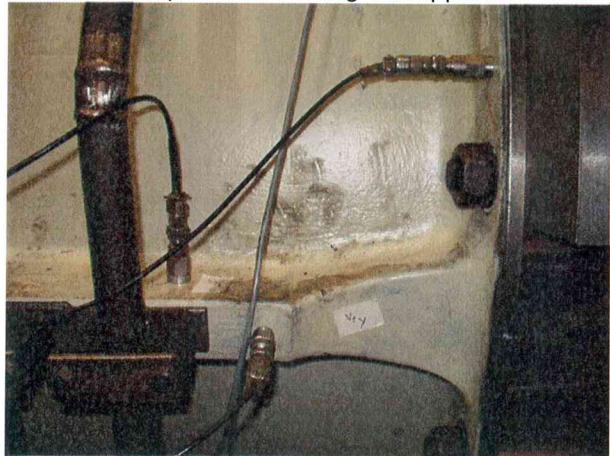
Measurement positions at the gear support

The accelerometer was connected by magnetic clamps at the positions listed in Table 1. Additional pictures of the measurement positions are presented in Appendix A.

Welle / shaft	Position / position	x- Richtung (axial)	y- Richtung (horiz.)	z- Richtung (vertik.)
Getriebeabstützung gear support	rotorseitig 3 Uhr rotorside 3 o'clock	V1x	V1y	V1z
Antriebswelle input shaft	Deckel cover	V2x	V2y	V2z
Abtriebswelle output shaft	generatorseitig generator side	V3x	V3y	V3z

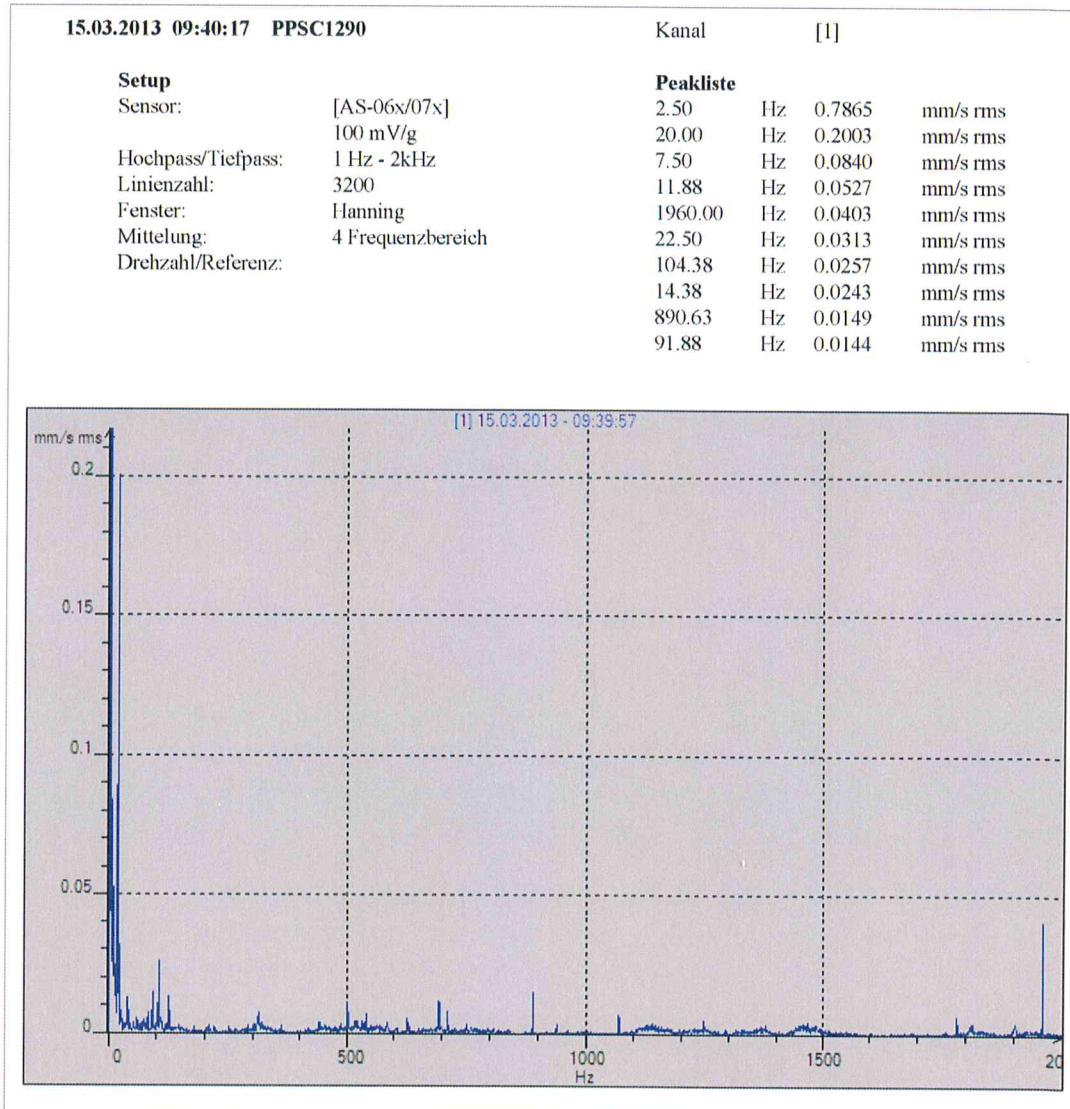
Position V1y: gear support, horizontal

The spectra of the vibration measured at the positions listed in Table 1 are presented in Appendix B. Vibrations which are caused by the measurement system are excluded from the evaluation. The vibration velocity which is related to the gearbox is small. The highest peak is about 0.32 mm/s at 1703Hz, measured at the output shaft in vertical direction.
